Manhole Inspection Summary

Manhole # S02YY1004MH

Insp Date: **10/11/06 12:18 PM**

Location Address: **6305 PARK HEIGHTS AVE**

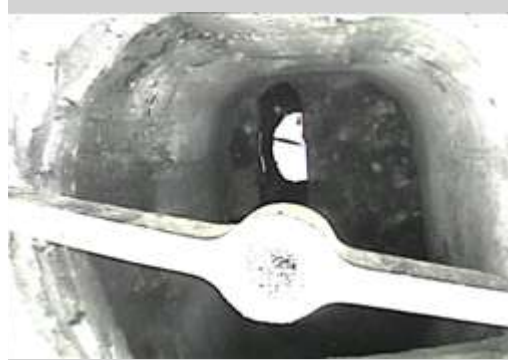
Top View

Adjustment and Corbel deterioration and infiltration. Bench debris.

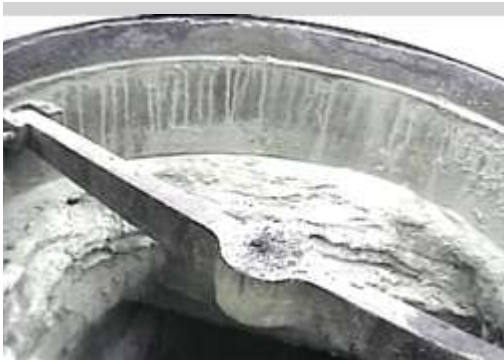
Defect

Frame leaks. Frame offset. Adjustment deterioration and infiltration.

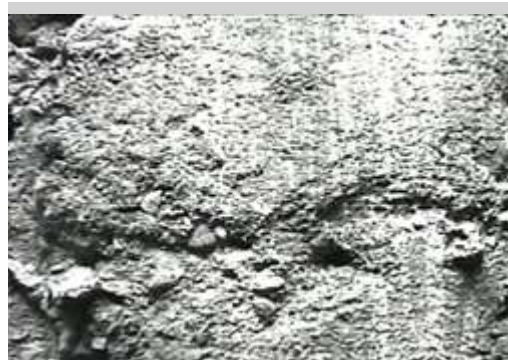
Defect

Missing steps.

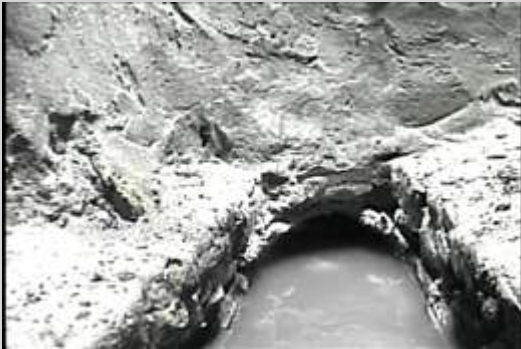
8 in. Circular Gravity Sewer Pipe Out @ 12 O'Clock

Infiltration: **Evidence** Pipe Seal Cond: **Unknown**

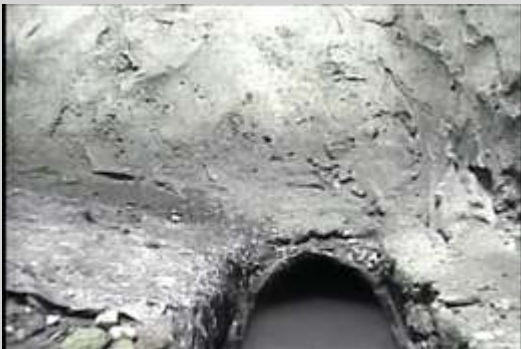
8 in. Circular Gravity Sewer Pipe In @ 6 O'Clock

Barrel infiltration.

Infiltration: **Evidence** Pipe Seal Cond: **Unknown**
